Smart motorways

Incident and infrastructure investigation

M6 Junction 5 to 6

Highways England response

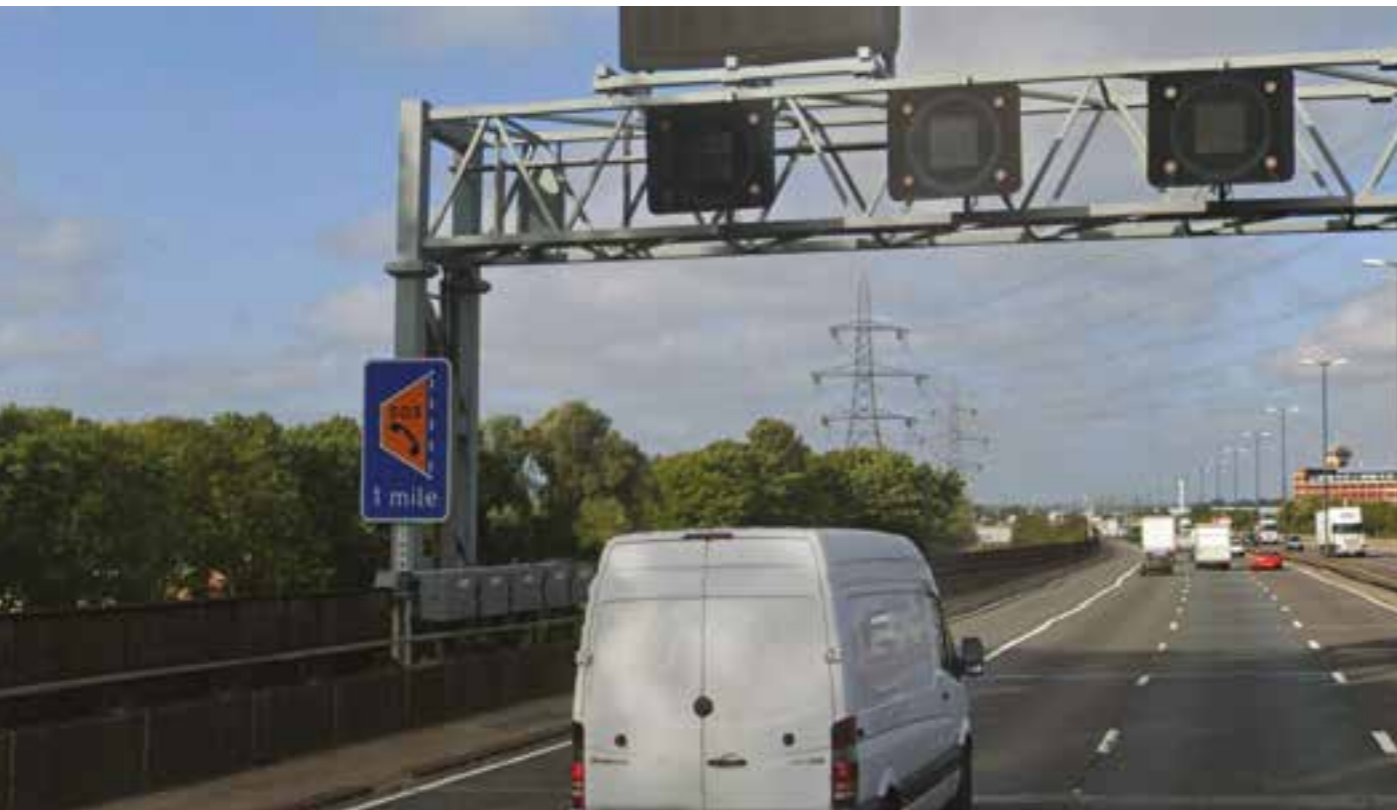
- The current signing for emergency areas is mainly provided by attaching the signs on available gantries, due to the restrictions in installing standalone signposts on the viaduct. The limitations around sign placement means some of the signing is not at the exact recommended distance, and the distance displayed on the signs is not always the exact distance to the next emergency area.

Figure 1 Emergency area approach sign on Bromford Viaduct mounted on a gantry
© Google

- In both the northbound and southbound directions, signing for the emergency areas will be enhanced. This will reduce the risk of drivers missing the emergency area, or stopping in a live running lane because they are unaware of the distance to the next emergency area
- Signage for the emergency areas will be enhanced

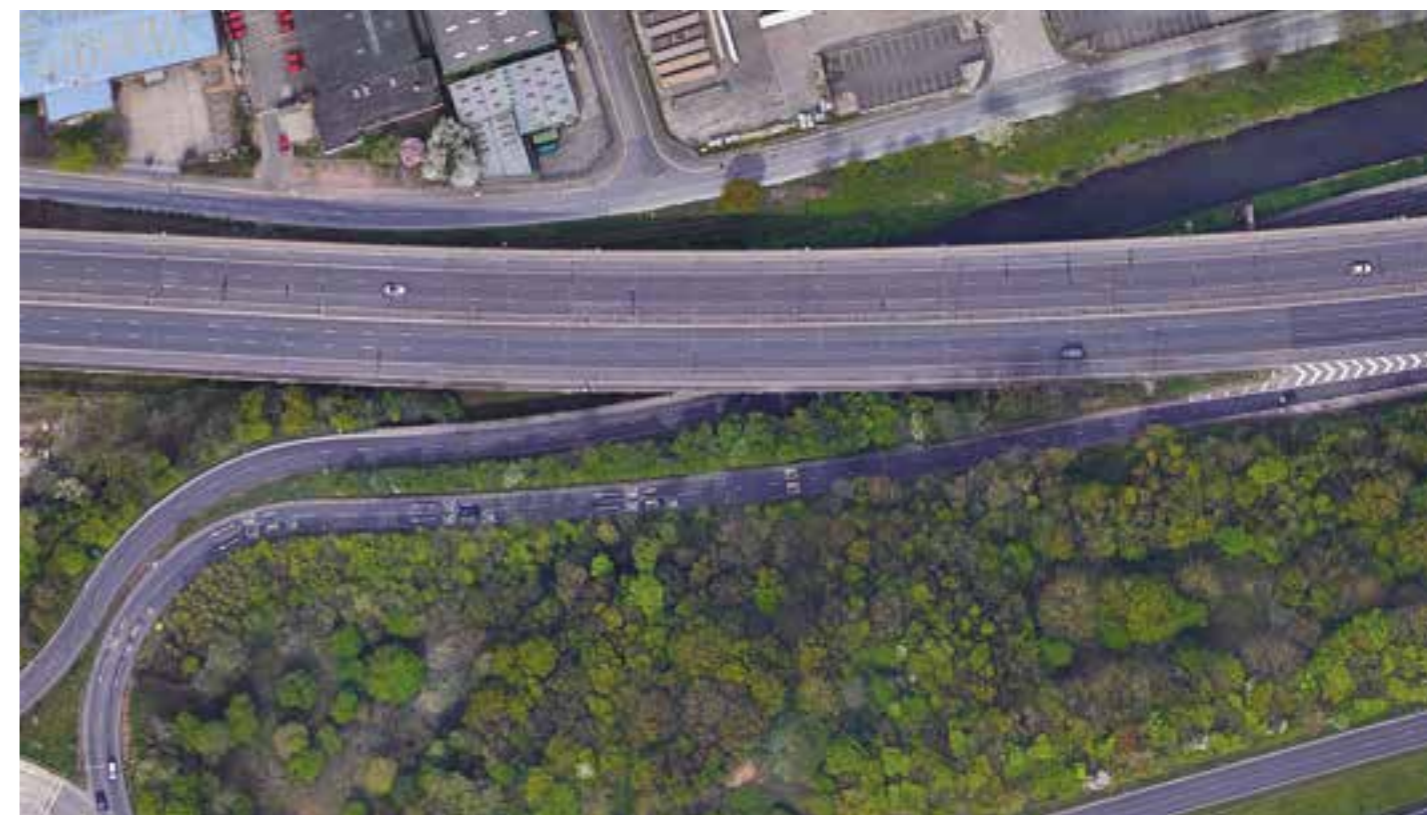
Figure 2 M6 J5 northbound exit slip road (shown on lower portion of image) an emergency area is to be implemented on this exit slip road © Google

For the recommendation to provide an additional place of relative safety at the J5 northbound exit slip road, we have completed a review as part of the development work to prepare for the upgrade to ALR of the M6 J4 to J5. This work is due to complete by March 2023. An additional emergency area will be installed on M6 J5 northbound exit slip road as part of the scheme.

The implementation of the emergency area at the northbound exit slip road will fulfil this recommendation.

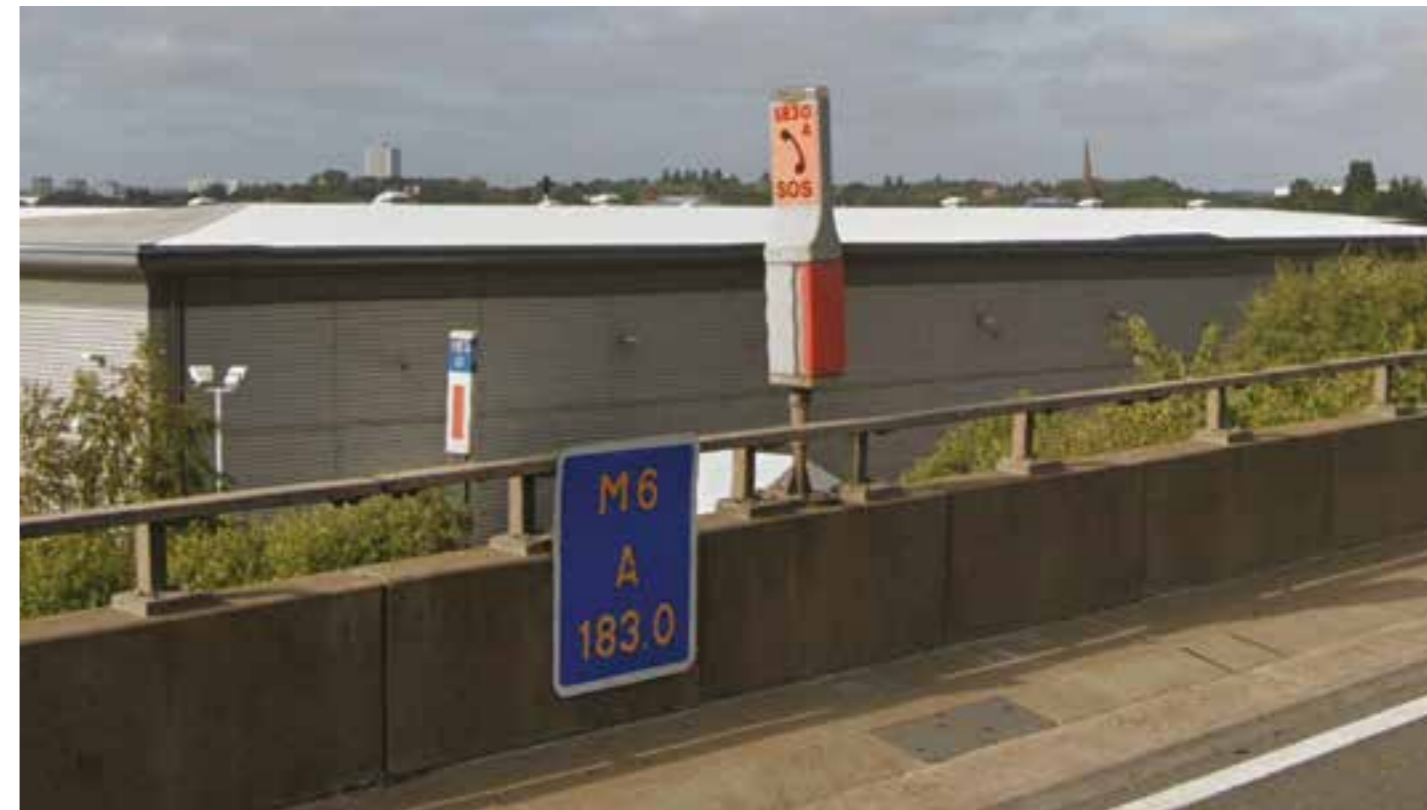
There is a total of 11 emergency roadside telephones between junction 5 and 6 (six northbound and five southbound). There is an emergency roadside telephone in each of the two emergency areas, and the other nine are provided on the top of the parapet. These are not regularly spaced; some are approximately 0.6 miles apart but at the northern end there are two pairs located 328 yards apart. Although the usage figures for the telephones outside of the emergency areas are low, we believe on balance there is no benefit to decommissioning them at this time.

Figure 3 Parapet mounted emergency roadside telephone on Bromford Viaduct
© Google

When the section was converted to smart motorway in 2014, a departure from standard was agreed based on a safety risk assessment about the provision of the telephones. When the section is converted to ALR, we propose that they should be removed as they will be adjacent to a running lane (with the exception of those in an emergency area). The implementation of stopped vehicle detection means that any road users who stop on the viaduct should be identified by the Regional Operations Centre before users have a chance to access the telephone. Retention of the telephones for now will also remove the risk to road workers and potential road user disruption to remove them.

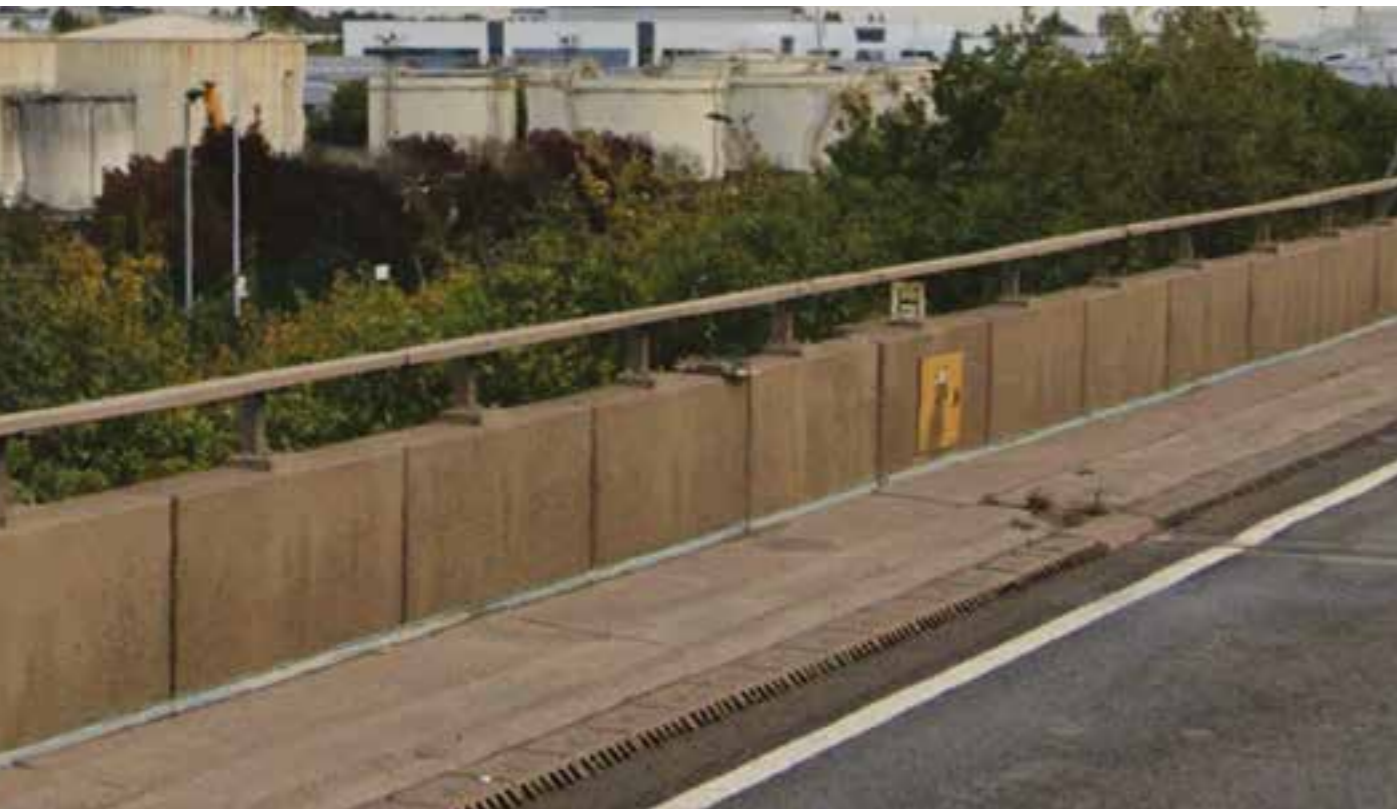
The incident and infrastructure investigation report suggested providing coloured surfacing on the area between the nearside road marking in and the viaduct parapet. Information signs at regular points along the parapet edge at a right angle to the carriageway were also proposed. The report suggested that the signs should affirm the coloured area as somewhere to stand, for example “emergency area, await help”. In tandem, an information campaign, for example at local motorway service areas, was also recommended.

Figure 4 1.2 metre kerbed area between the edge of the carriageway and the parapet
© Google

We do not class this ‘hard strip’ as a place of relative safety, and therefore would not wish to create the impression that there is a walkway for road users to use. Therefore we do not intend to pursue this recommendation.

The implementation of this recommendation may conflict with the coloured surfacing used for emergency areas and create confusion for road users. When the ALR scheme is completed, the hard strip will be adjacent to a permanent running lane, which further supports the decision not to pursue this recommendation.
